AFWAL-TM-79-10

**TEST REPORT ON INFRARED
WARNING RECEIVER (IRWR) FLIGHT
VIBRATION MEASUREMENTS**

APRIL 1980

This test report presents data which define the vibration environments experienced by two infrared warning receiver (IRWR) units mounted on the HH-53 helicopter and the C-130E transport aircraft.

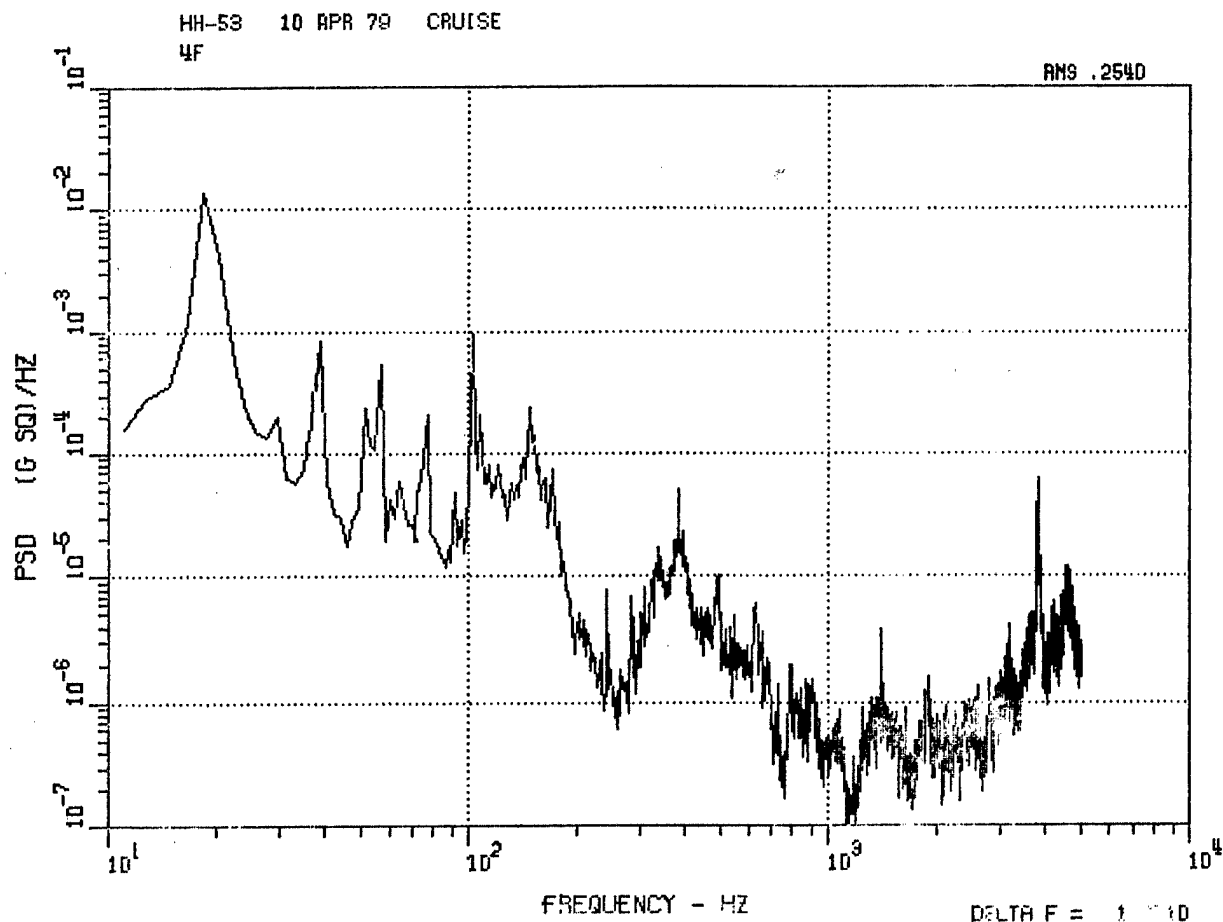
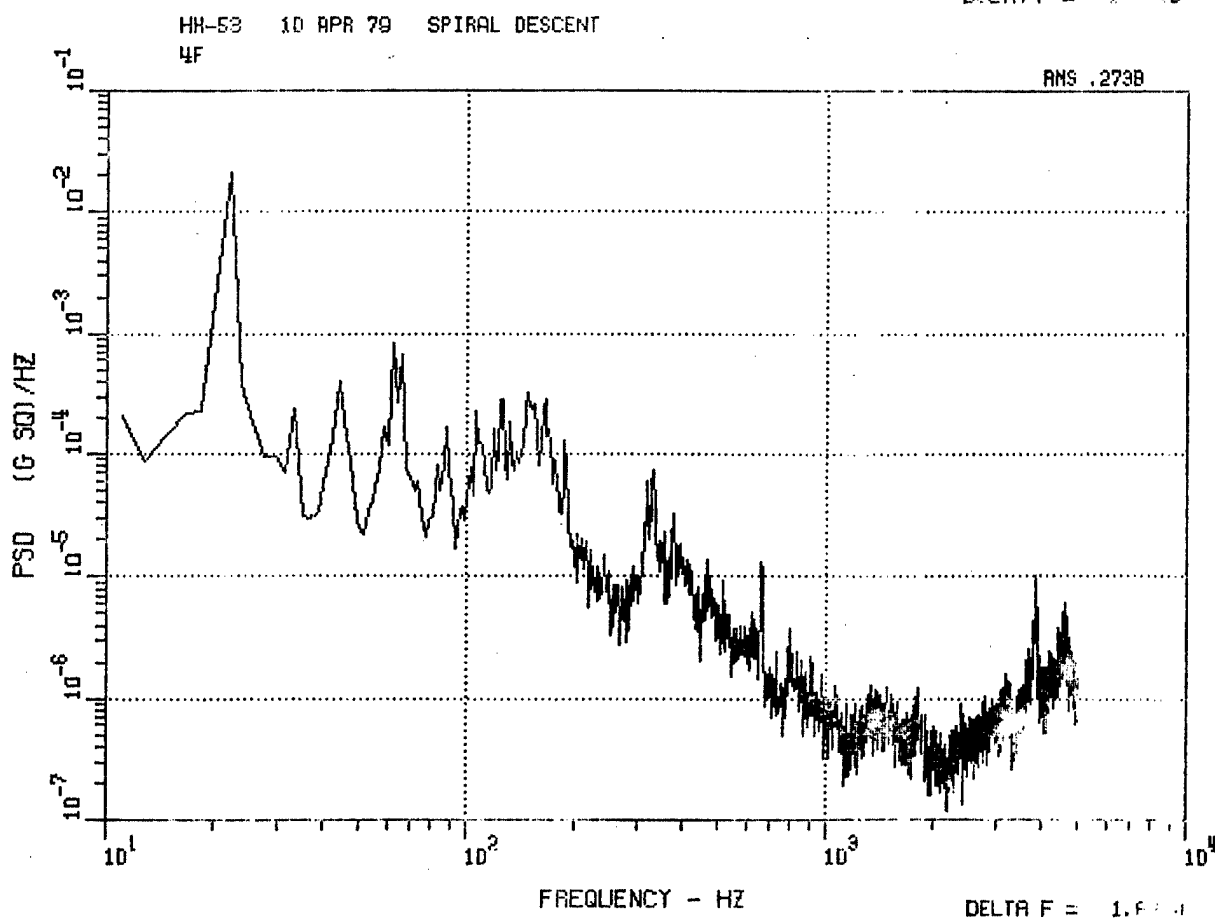
Figure 64. HH-53 Fwd Vertical Accelerometer 4F, Cruise and Spiral Descent.

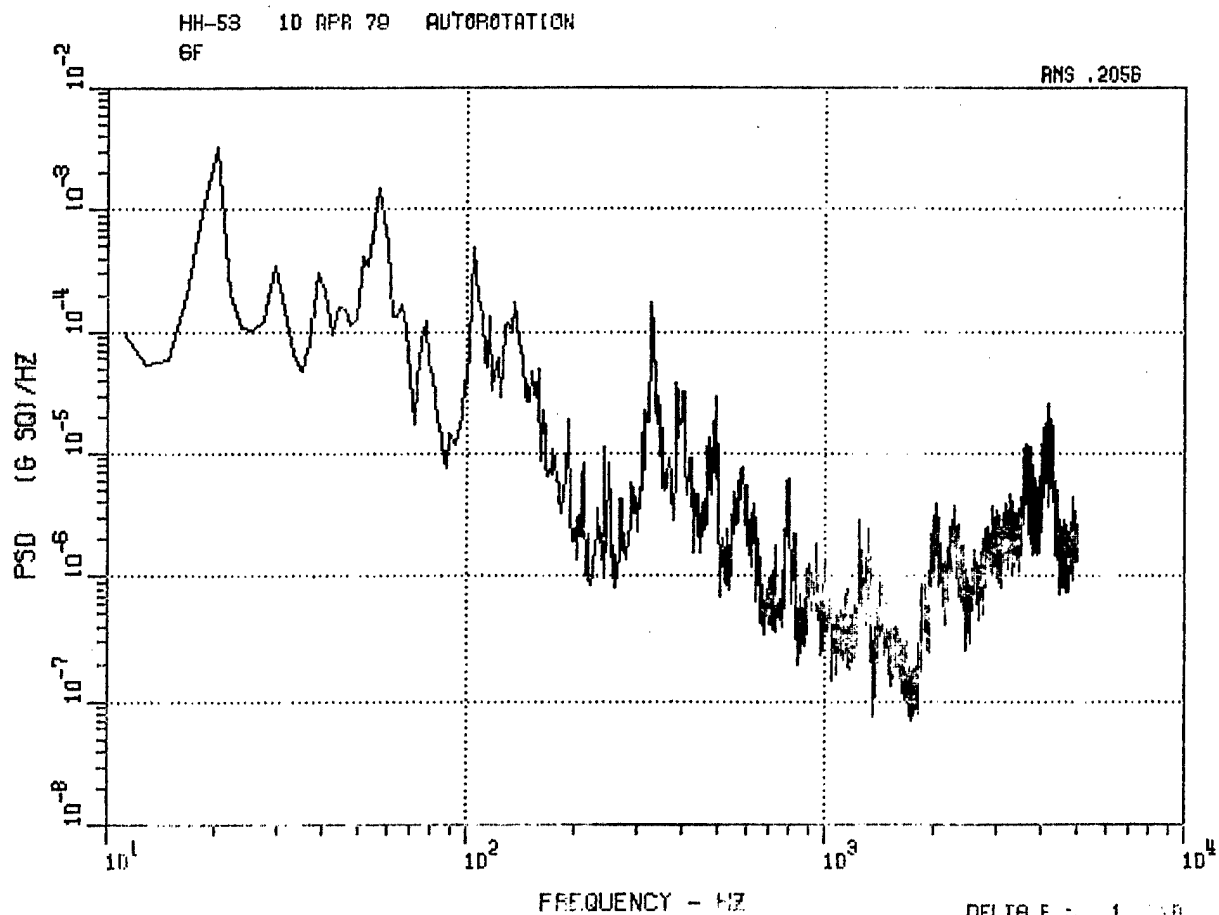
Figure 68. HH-53 Fwd Longitudinal Accelerometer 6F,
Autorotation and No-Signal Record.

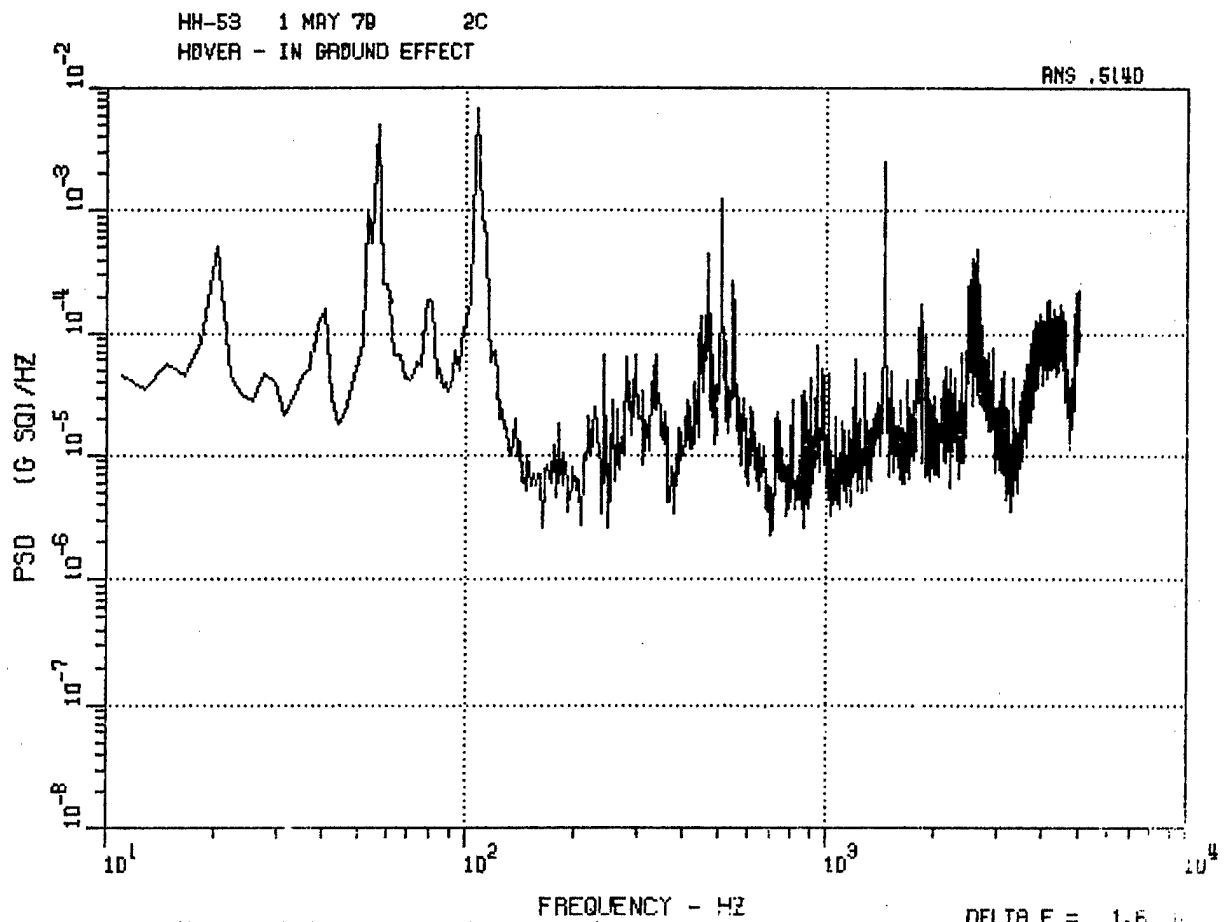
Figure 72. HH-53 Center Vertical Accelerometer 2C,
Hover IGE and Max Takeoff.

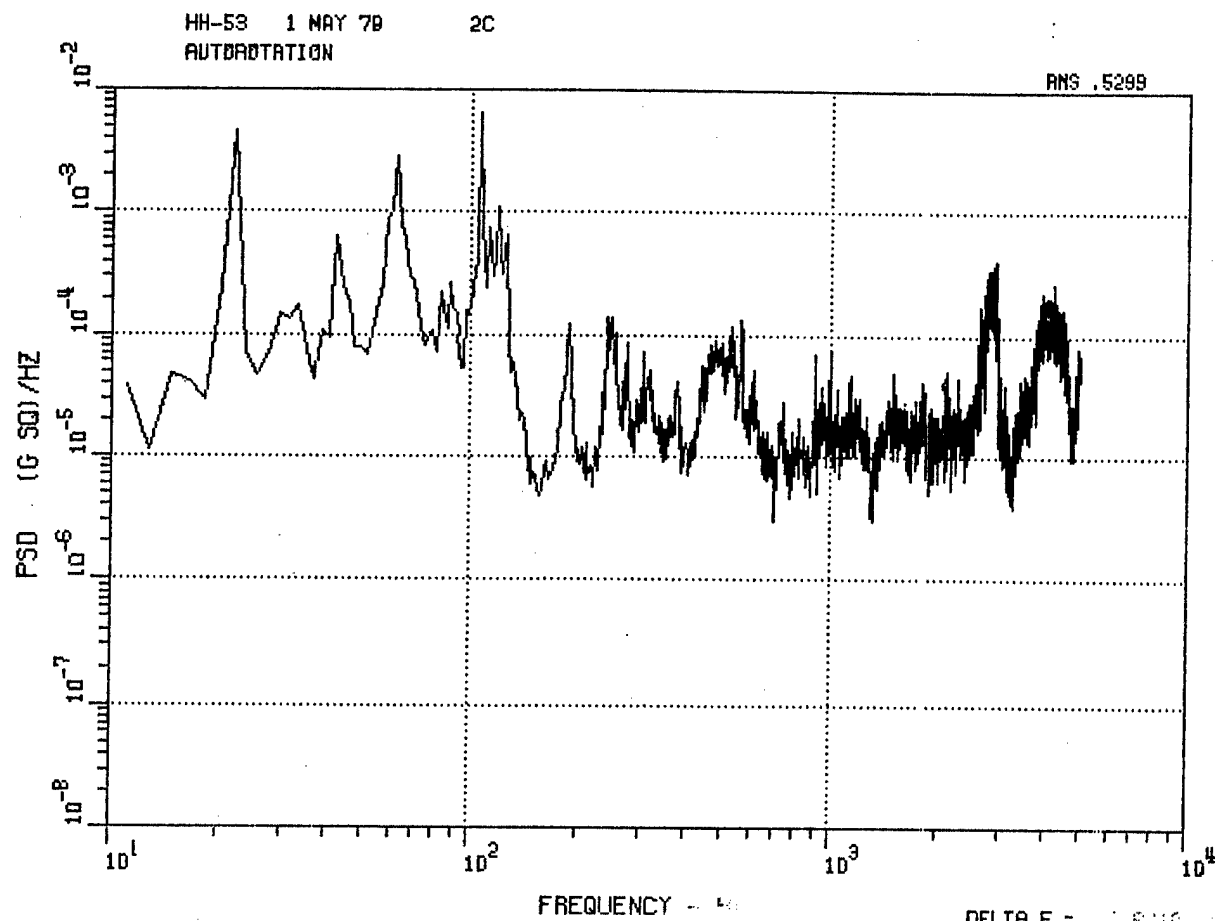
Figure 74. HH-53 Center Vertical Accelerometer 2C,
Autorotation and No-Signal Record.

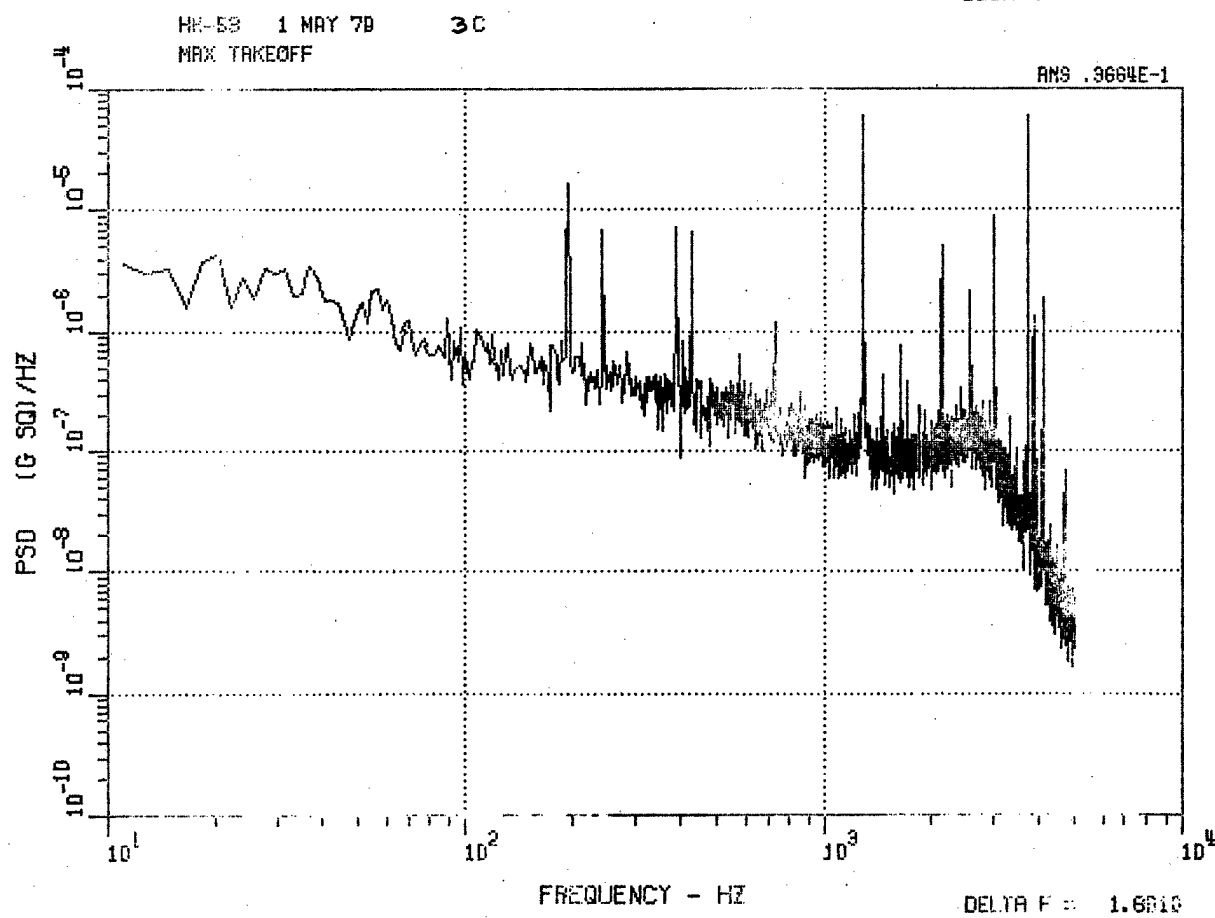
Figure 75. HH-53 Center Lateral Accelerometer 3C,
Hover IGE and Max Takeoff.

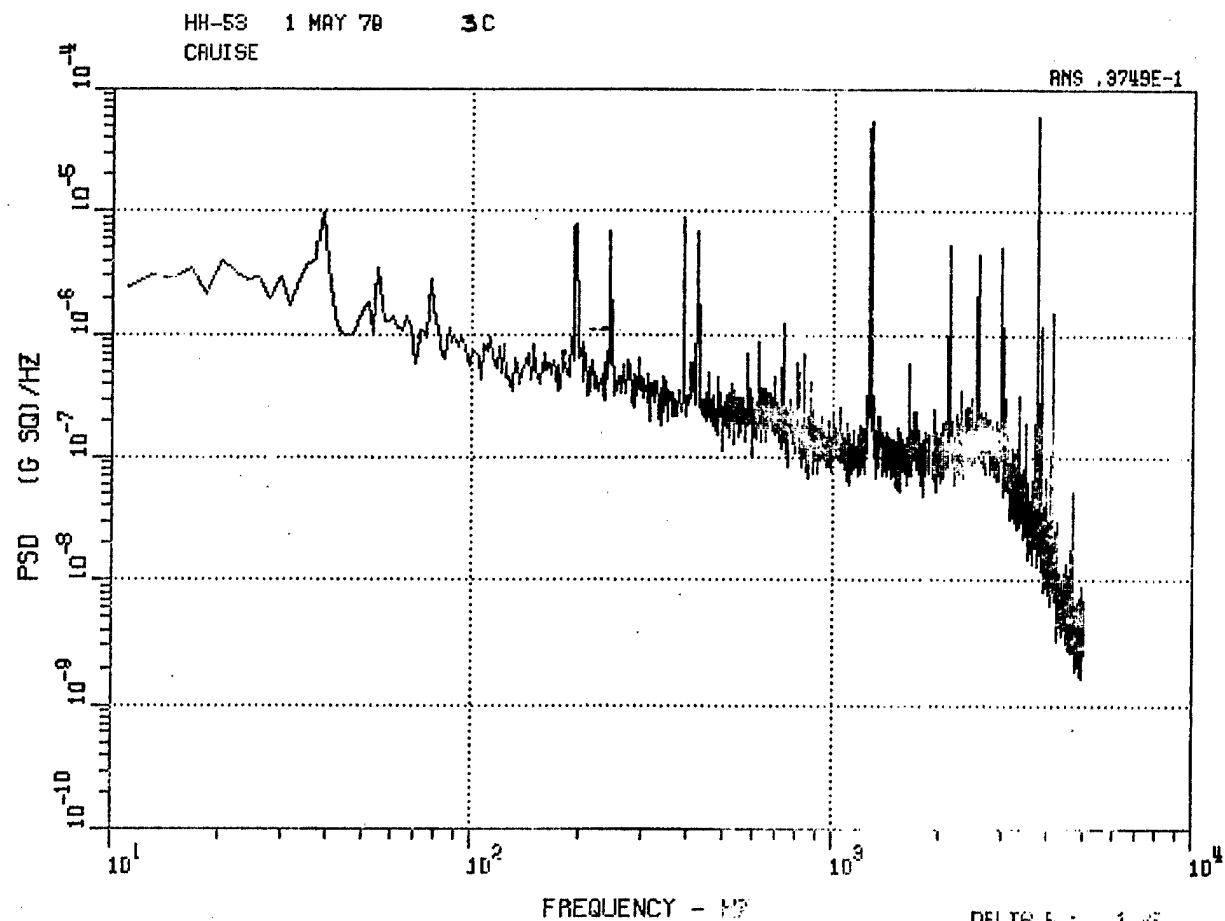
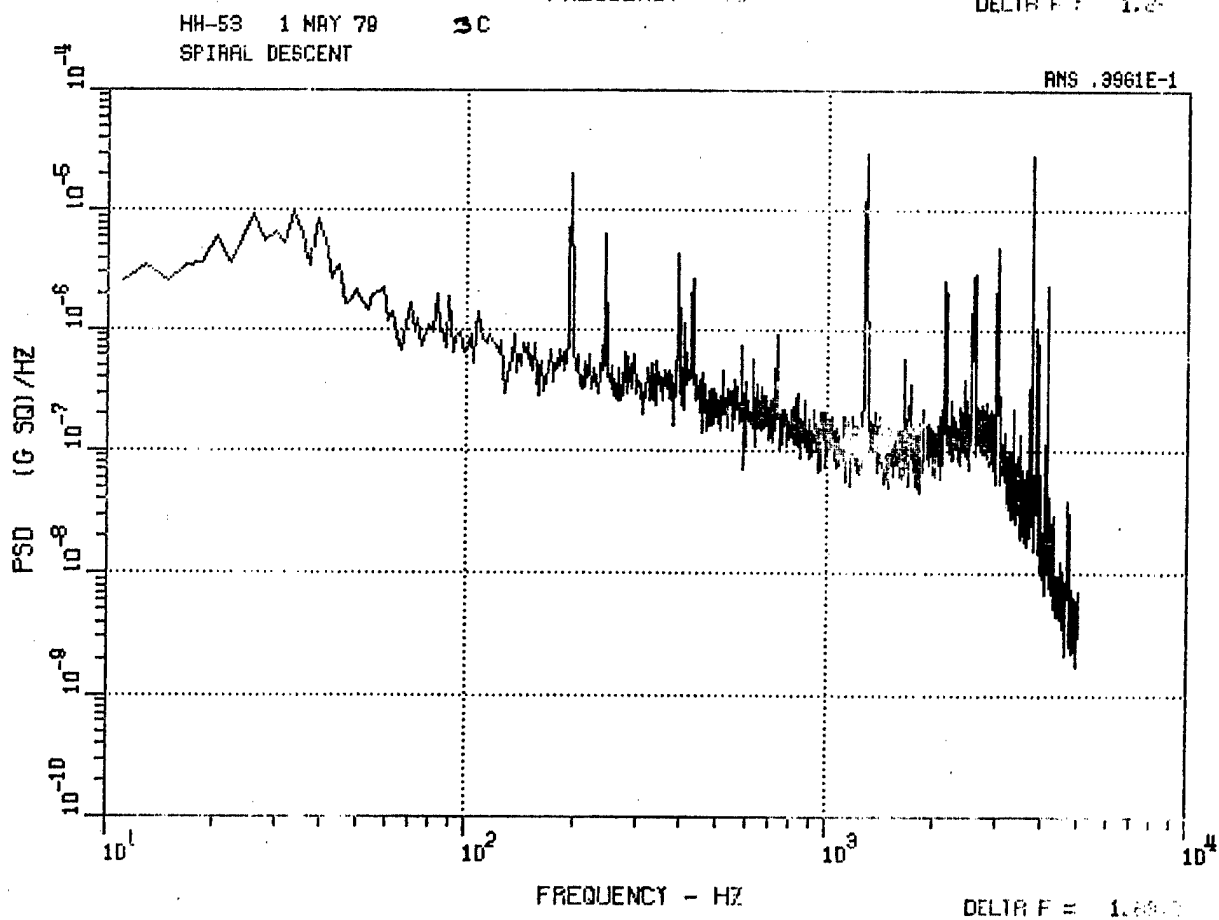
Figure 76. HH-53 Center Lateral Accelerometer 3C,
Cruise and Spiral Descent.

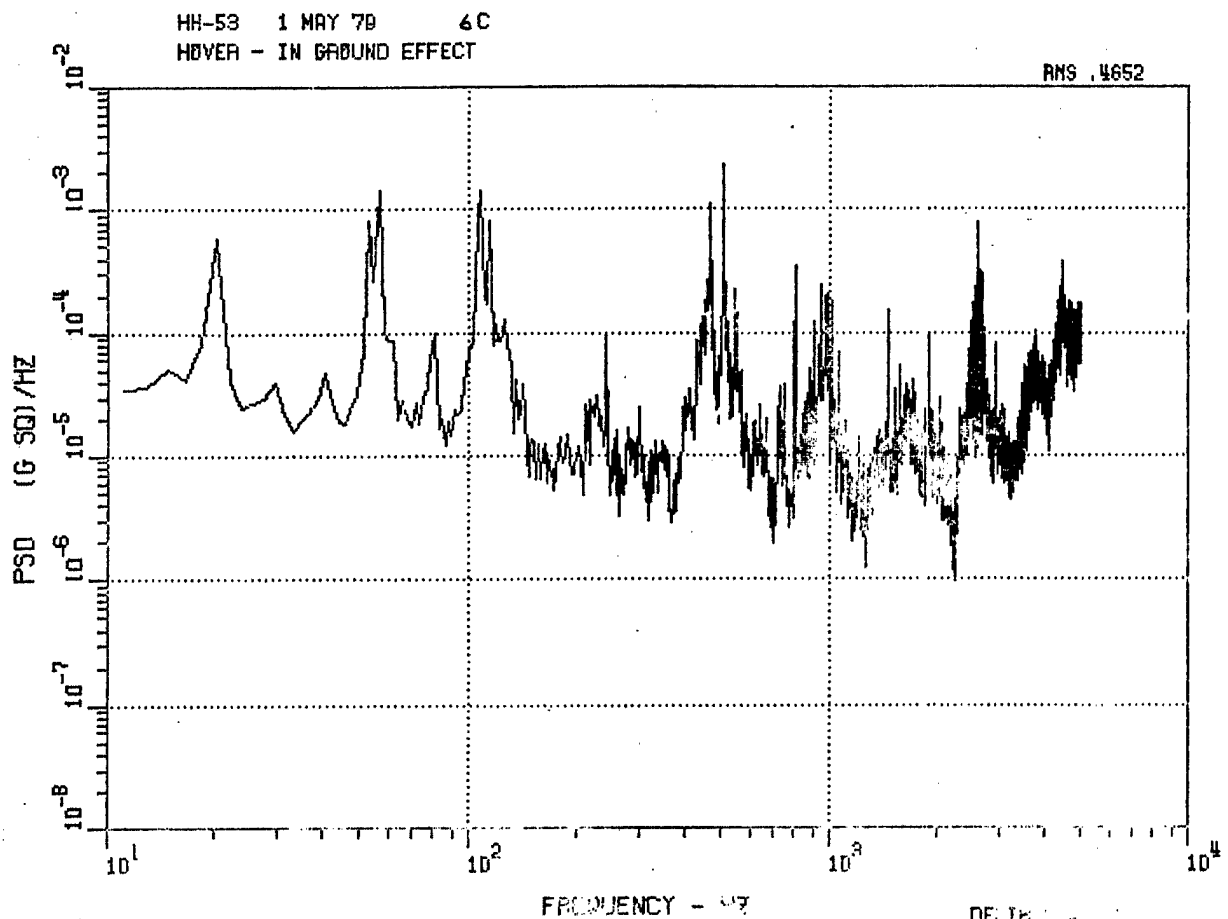
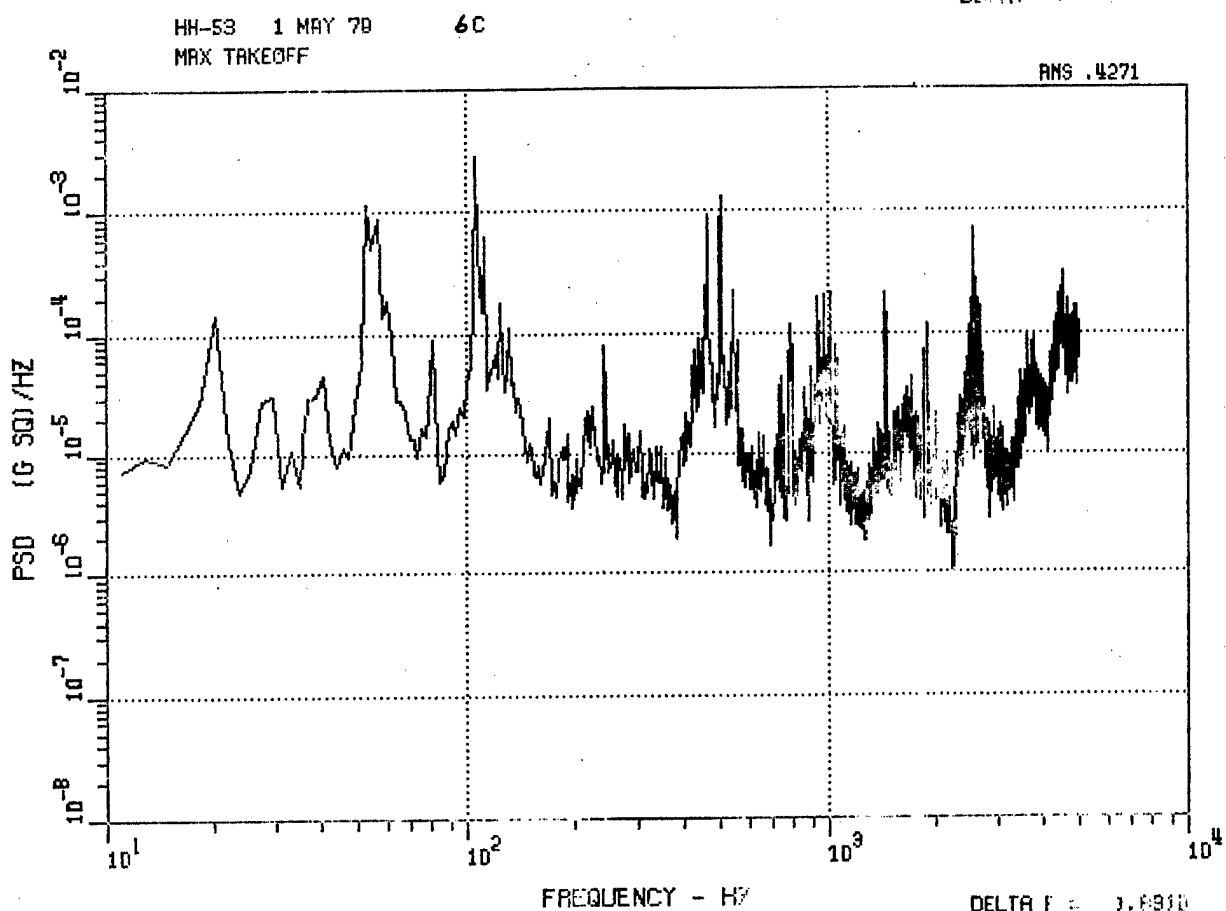
Figure 78. HH-53 Center Longitudinal Accelerometer 6C,
Hover IGE and Max Takeoff.

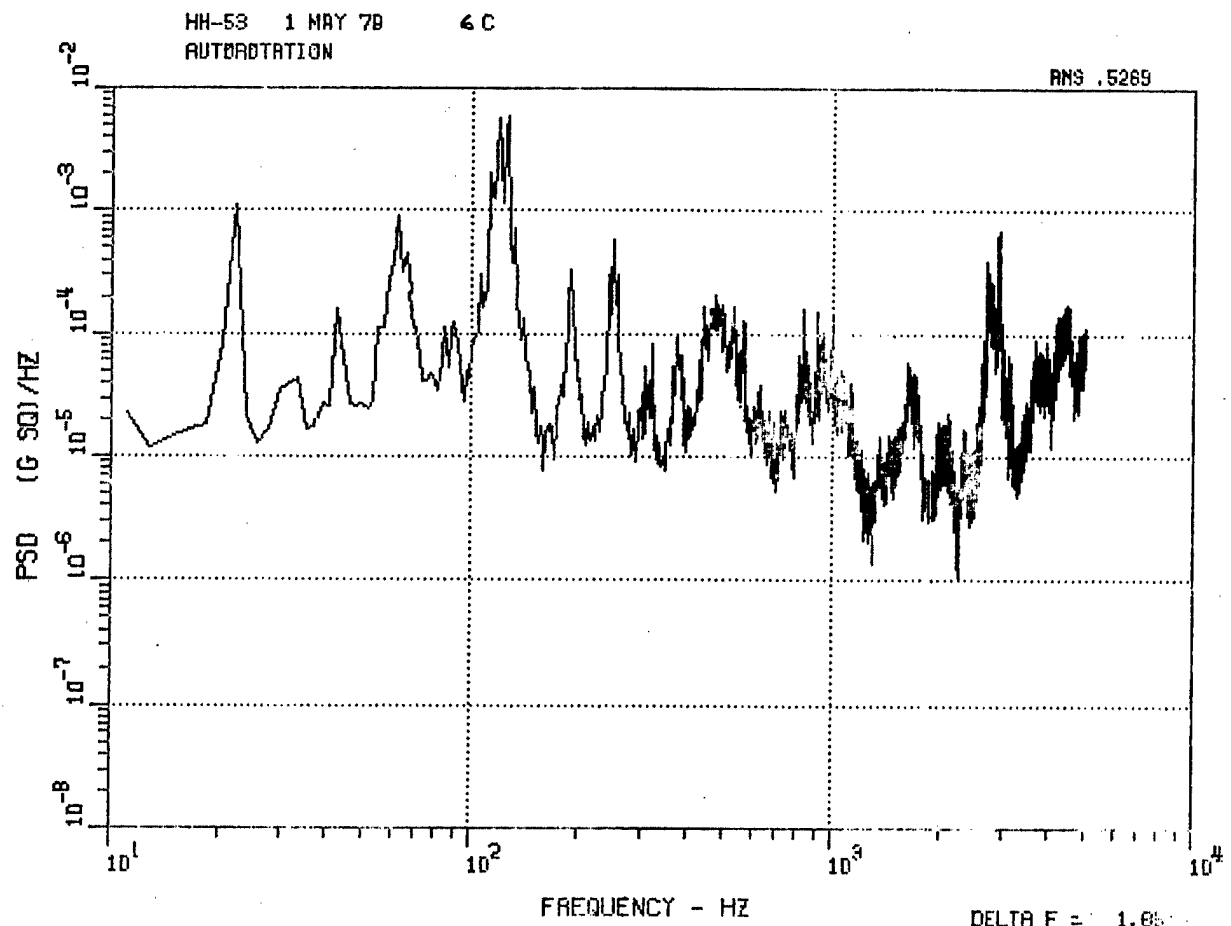
Figure 80. HH-53 Center Longitudinal Accelerometer 6C, Autorotation and No-Signal Record.

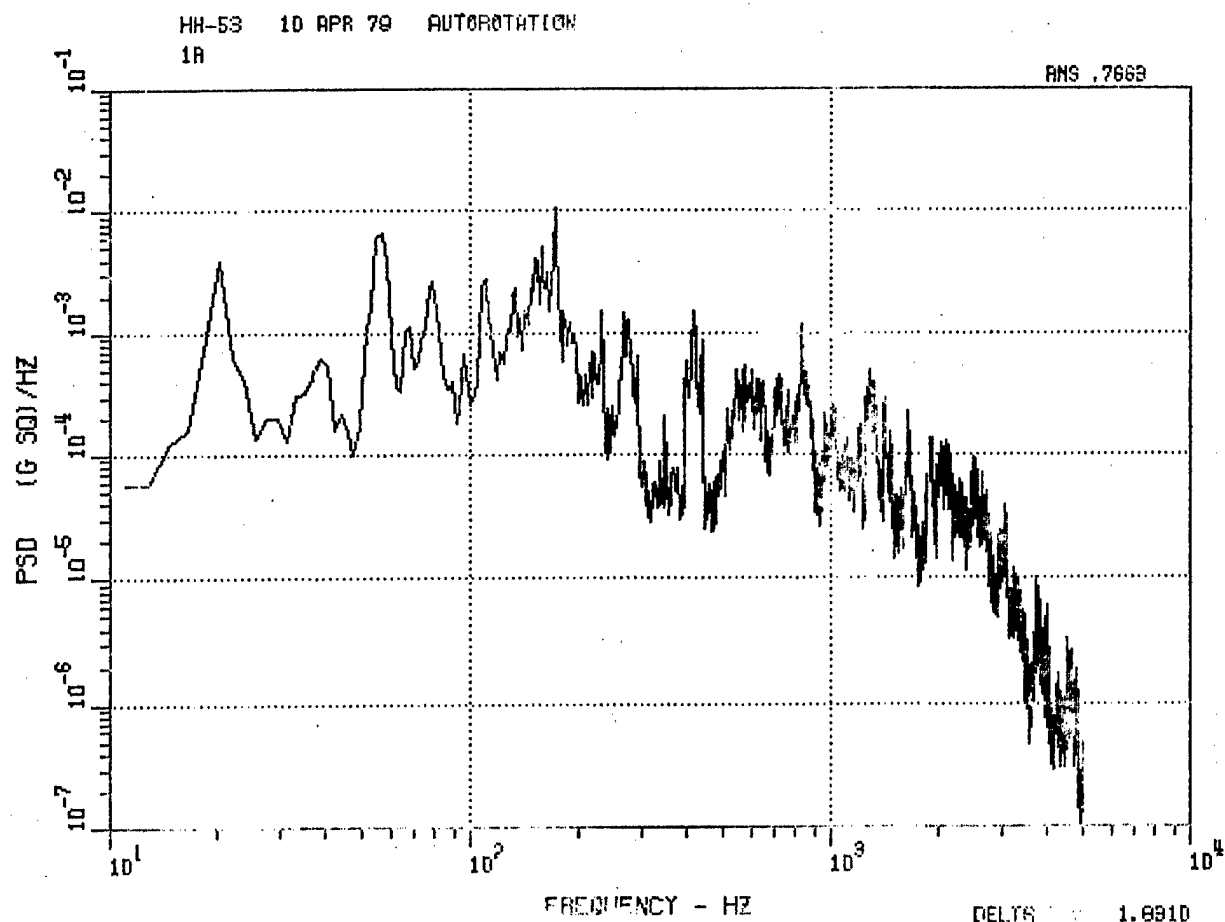
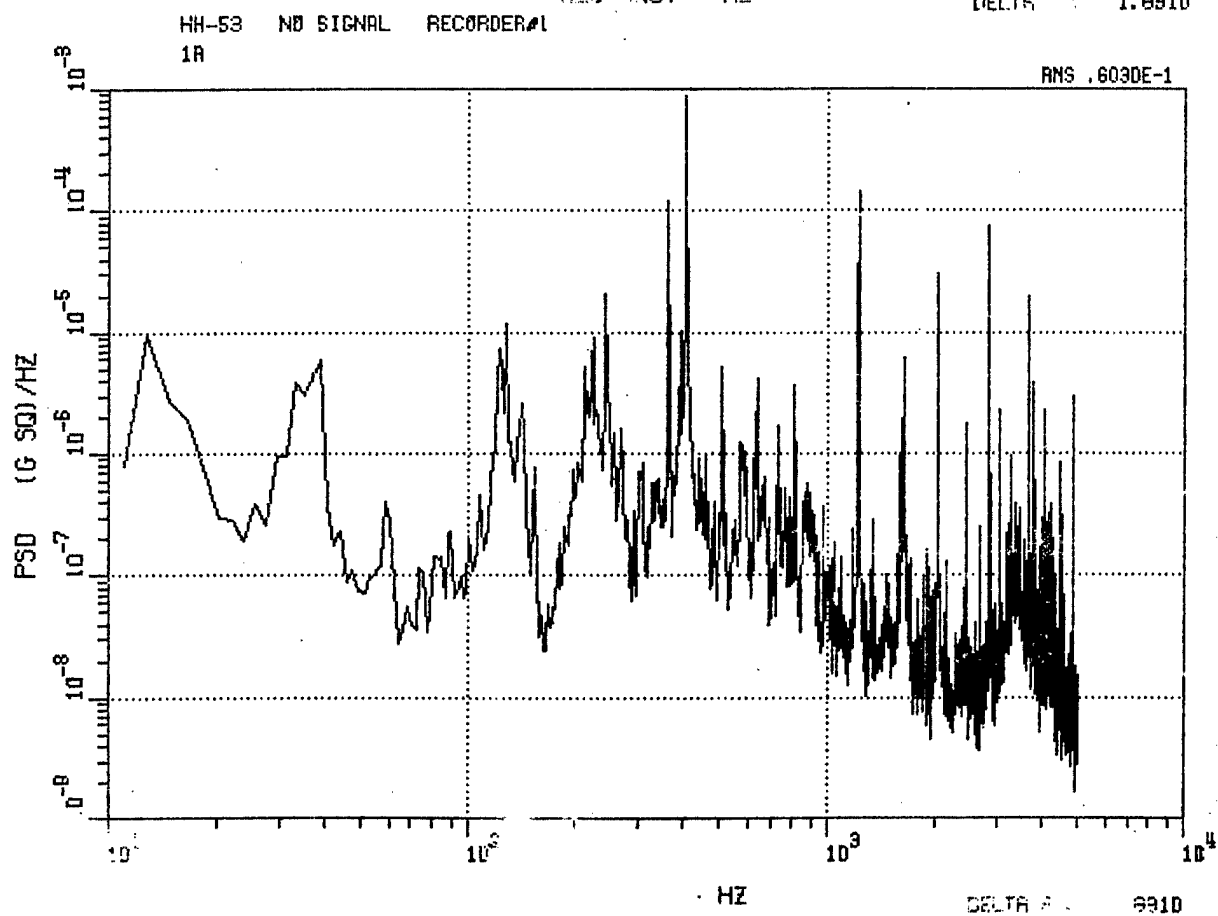
Figure 86. HH-53 Aft Lateral Accelerometer 1A,
Autorotation and No-Signal Record.

The aft AAR-43 location showed the highest vibration levels on the helicopter. The lateral accelerations (Sensor 1A) are shown in Figures 84-86, the vertical accelerations (Sensor 3A) are shown in Figures 87-89, and the longitudinal accelerations (Sensor 6A) are shown in Figures 90-92. The microphone data (MA), shown in Figures 93-95, show sound pressure levels of 111-124 dB, lower than the forward or center locations. The HH-53 helicopter vibration levels are generally lower than the corresponding C-130 levels, and are not expected to cause any difficulty in sensor operation.

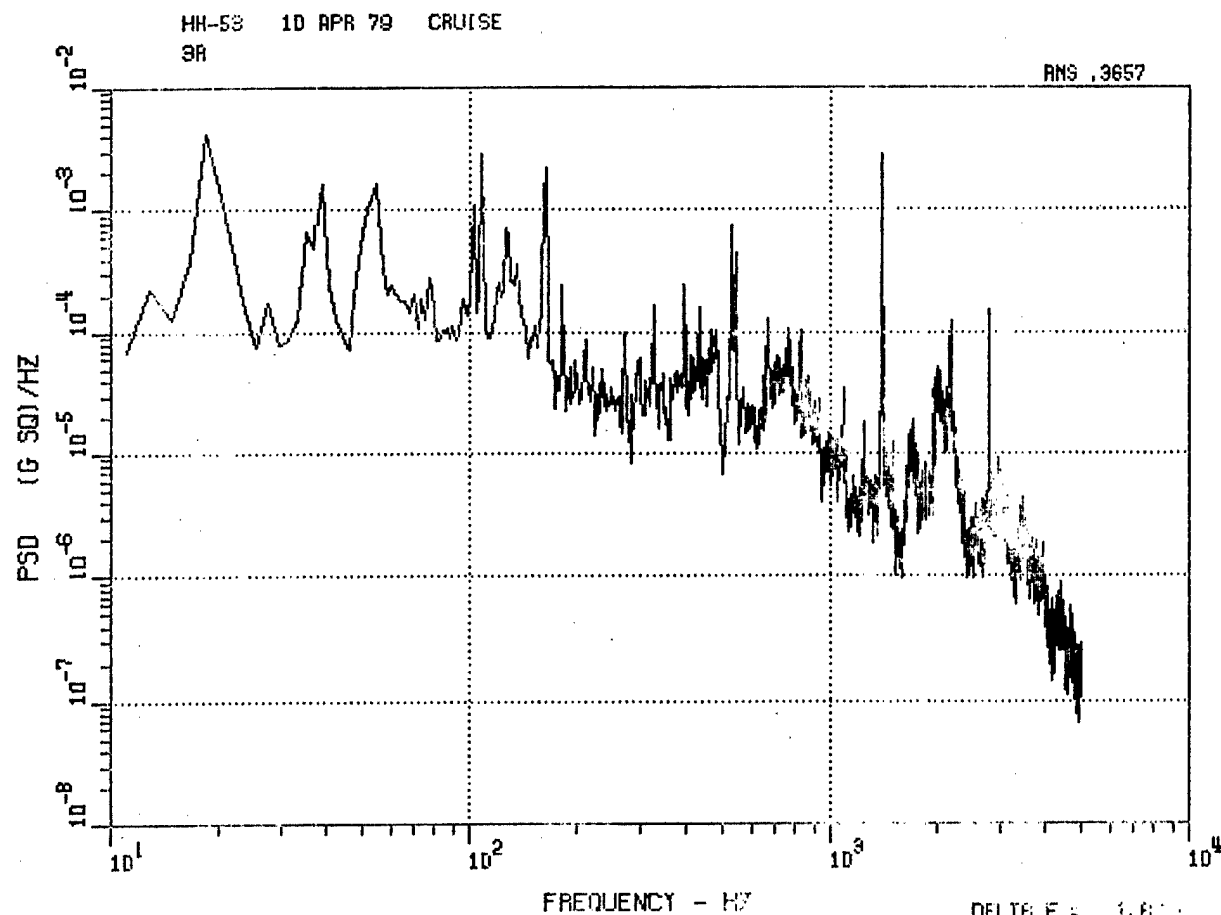
Figure 88. HH-53 Aft Vertical Accelerometer 3A,
Cruise and Spiral Descent.

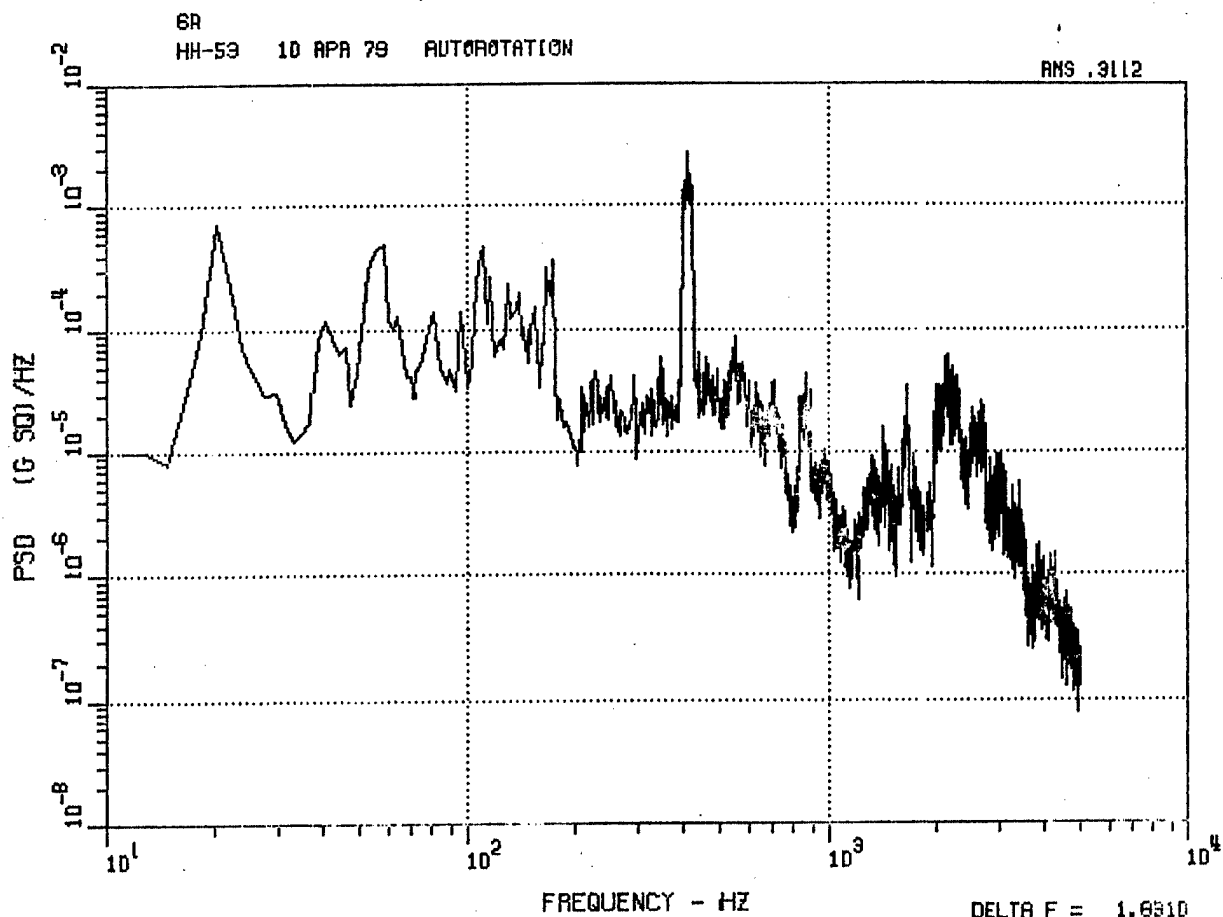
Figure 92. HH-53 Aft Longitudinal Accelerometer 6A, Autorotation and No-Signal Record.

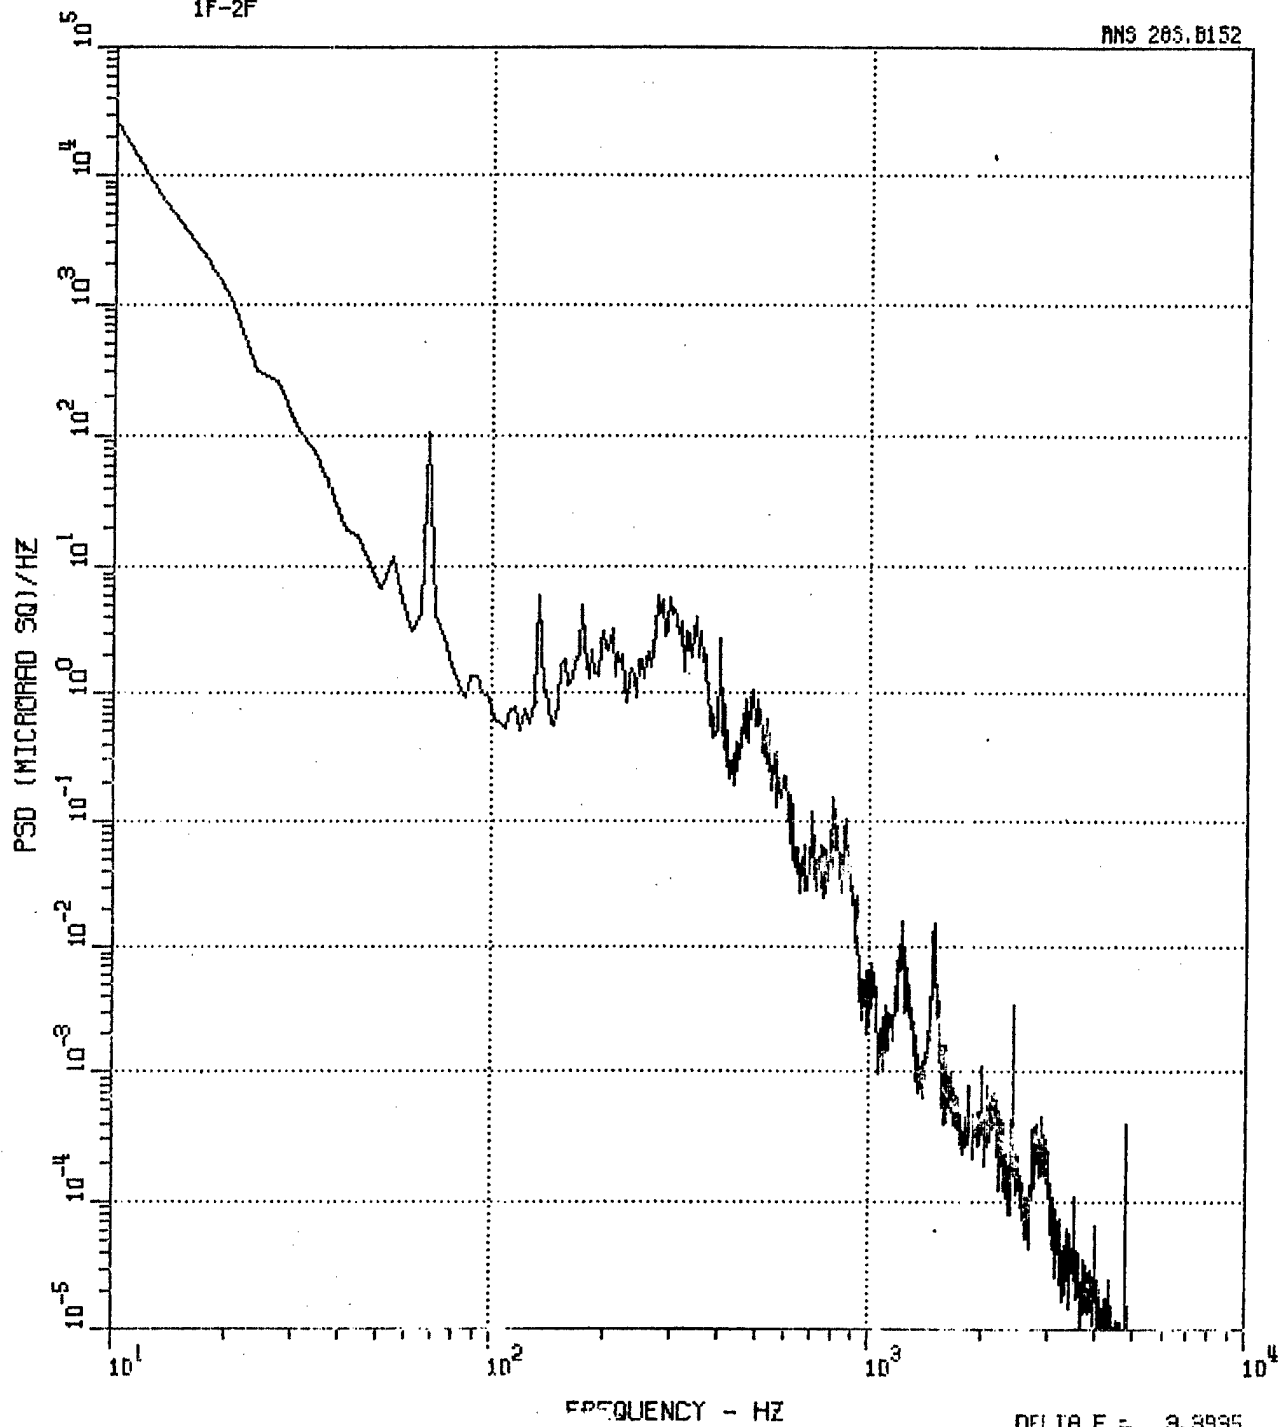
Figure 96. C-130 Fwd Roll PSD, 1F-2F, 1000 Ft, 250 Kt,
30 Deg.

Several pairs of linear accelerometer signals on the C-130 were combined to produce a measure of the angular accelerations experienced by the sensors. The sensors chosen are shown in Table 7 and the results are shown in Figures 96-100 for the selected flight condition of 250 knots, 30° bank, and 1000 feet altitude. The results, shown in PSDs of microradians squared per hertz, are for information only and were not used to evaluate the sensor vibration environments.

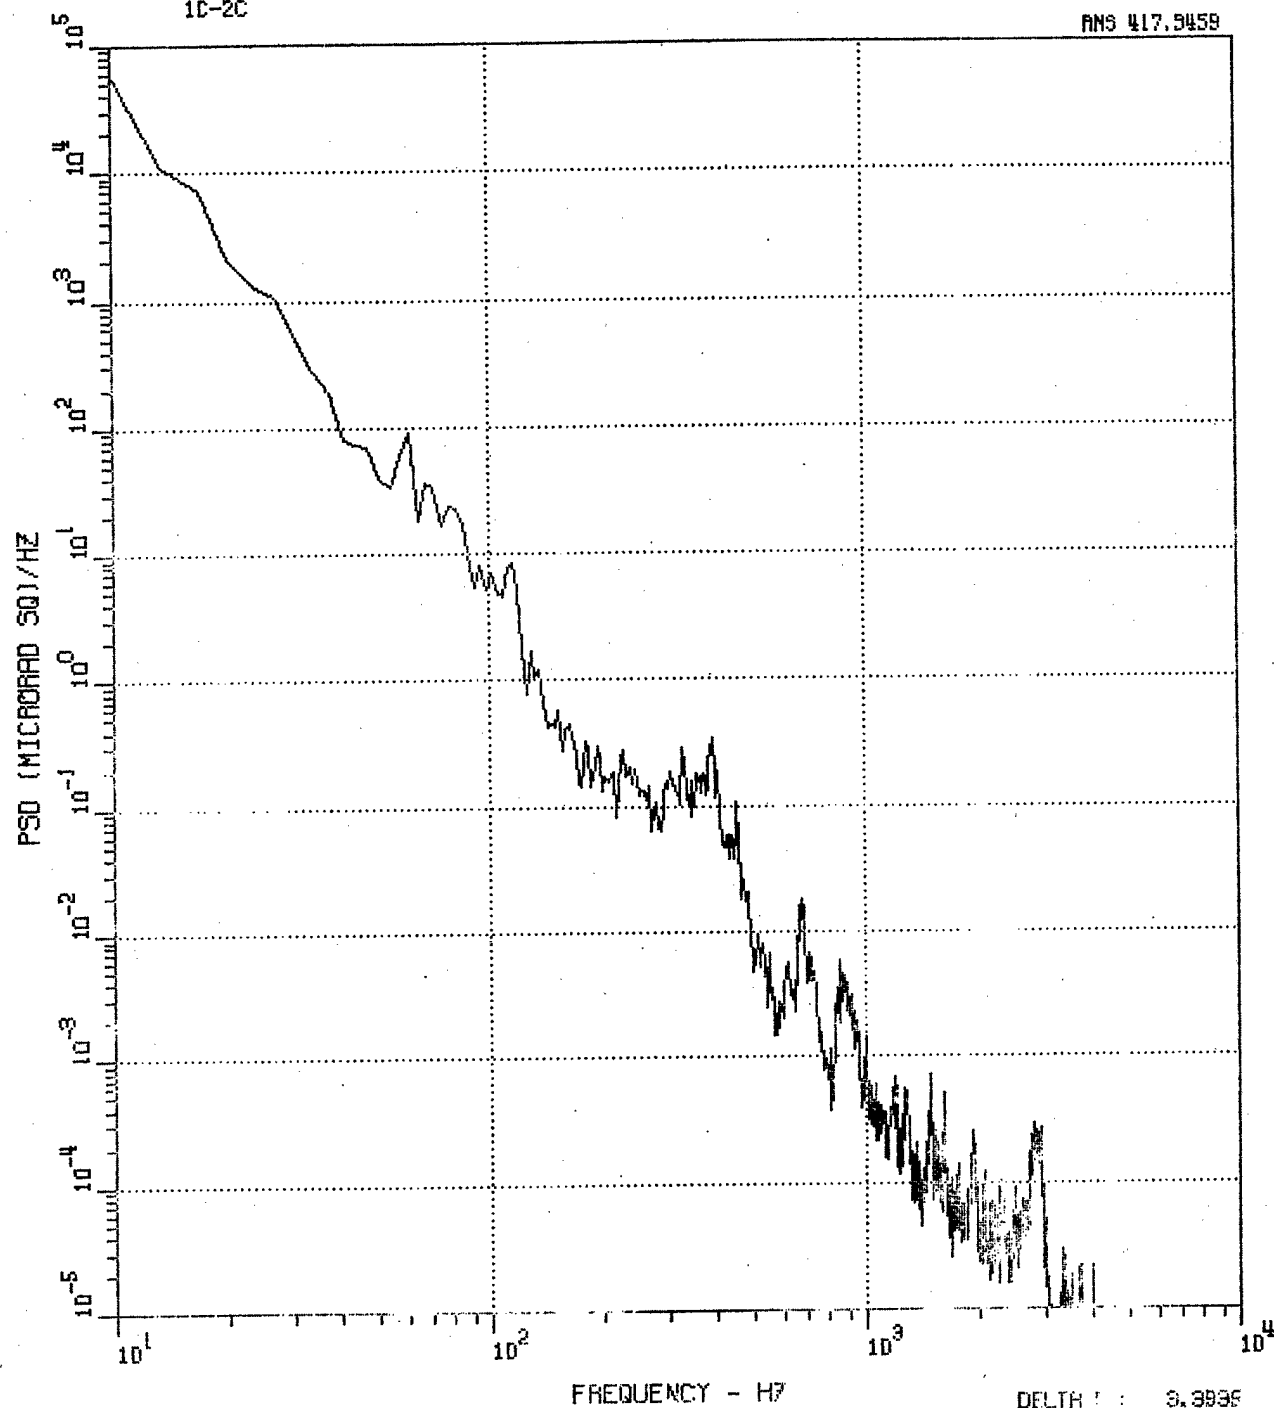
Figure 97. C-130 Center Roll PSD, 1C-2C, 1000 Ft, 250 Kt, 30 Deg.

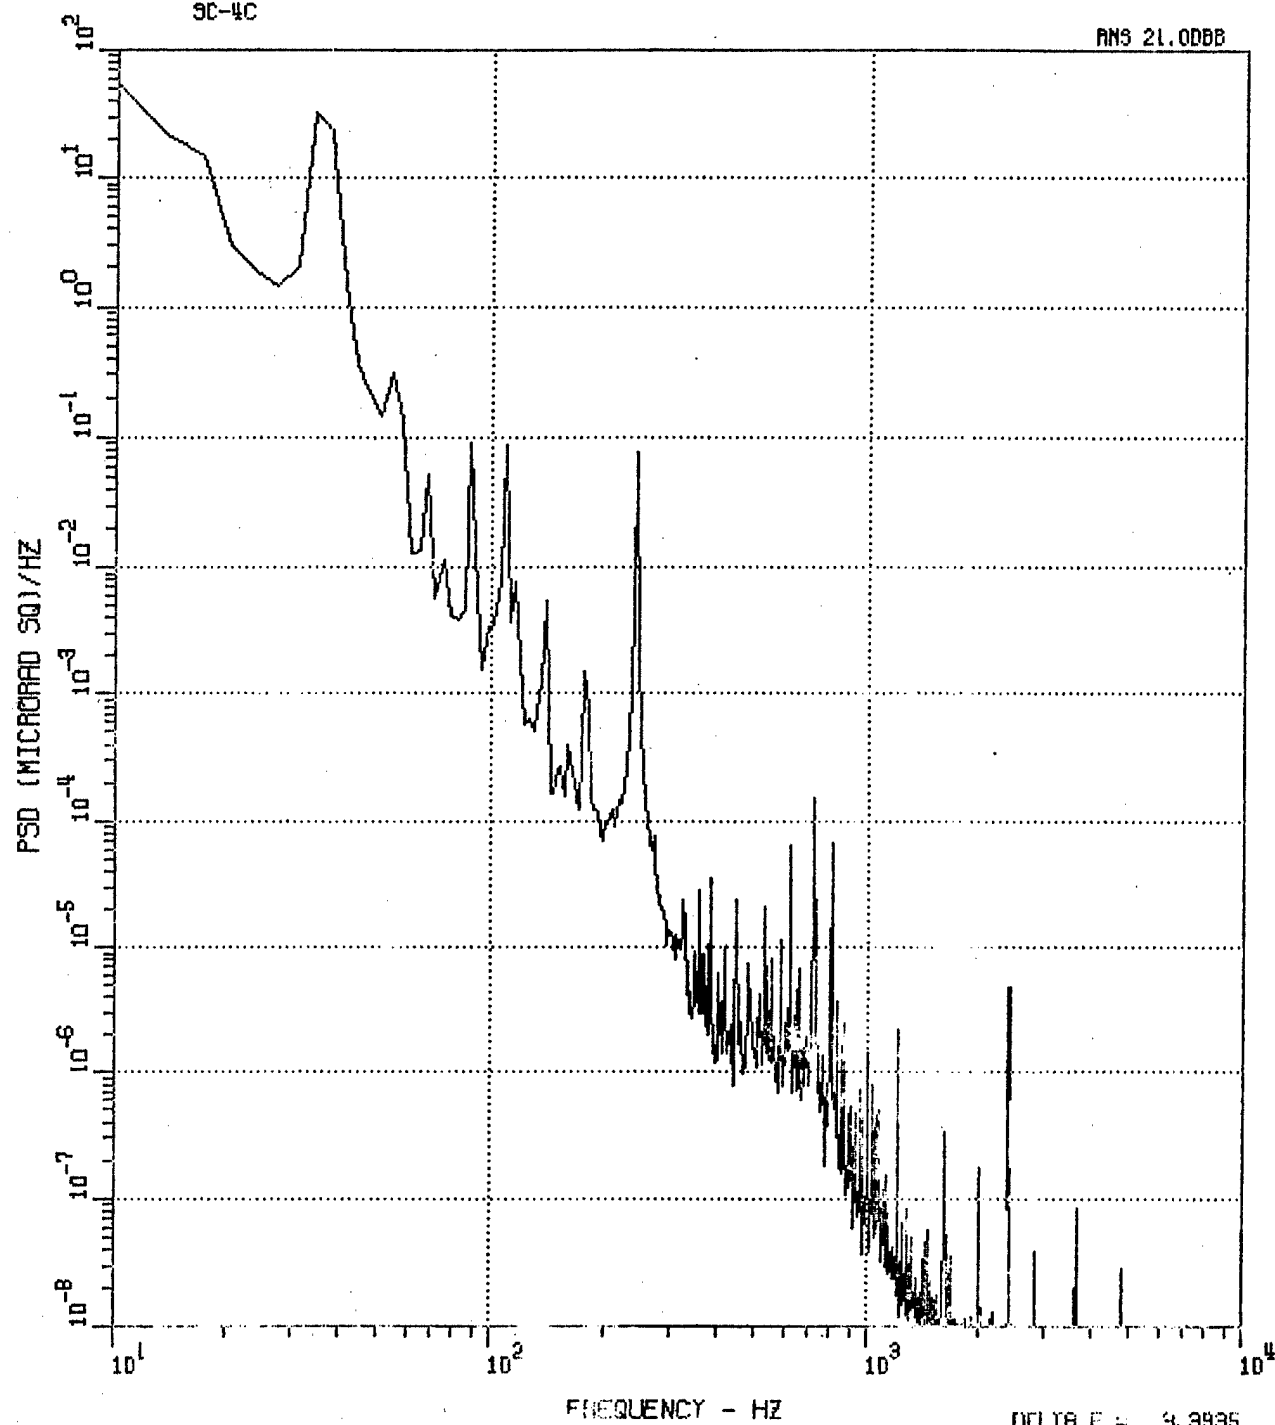
Figure 98. C-130 Center Yaw PSD; 3C-4C, 1000 Ft, 250 Kt, 30 Deg.
